Comprehensive Assessment Report

SY 2014 -2015

COMMUNITY SUPPORTED SCHOOL MAINTENANCE PILOT PROGRAM

Division of Environmental Health
Guam Department of Public Health and Social Services
Last Updated: 3/23/2015

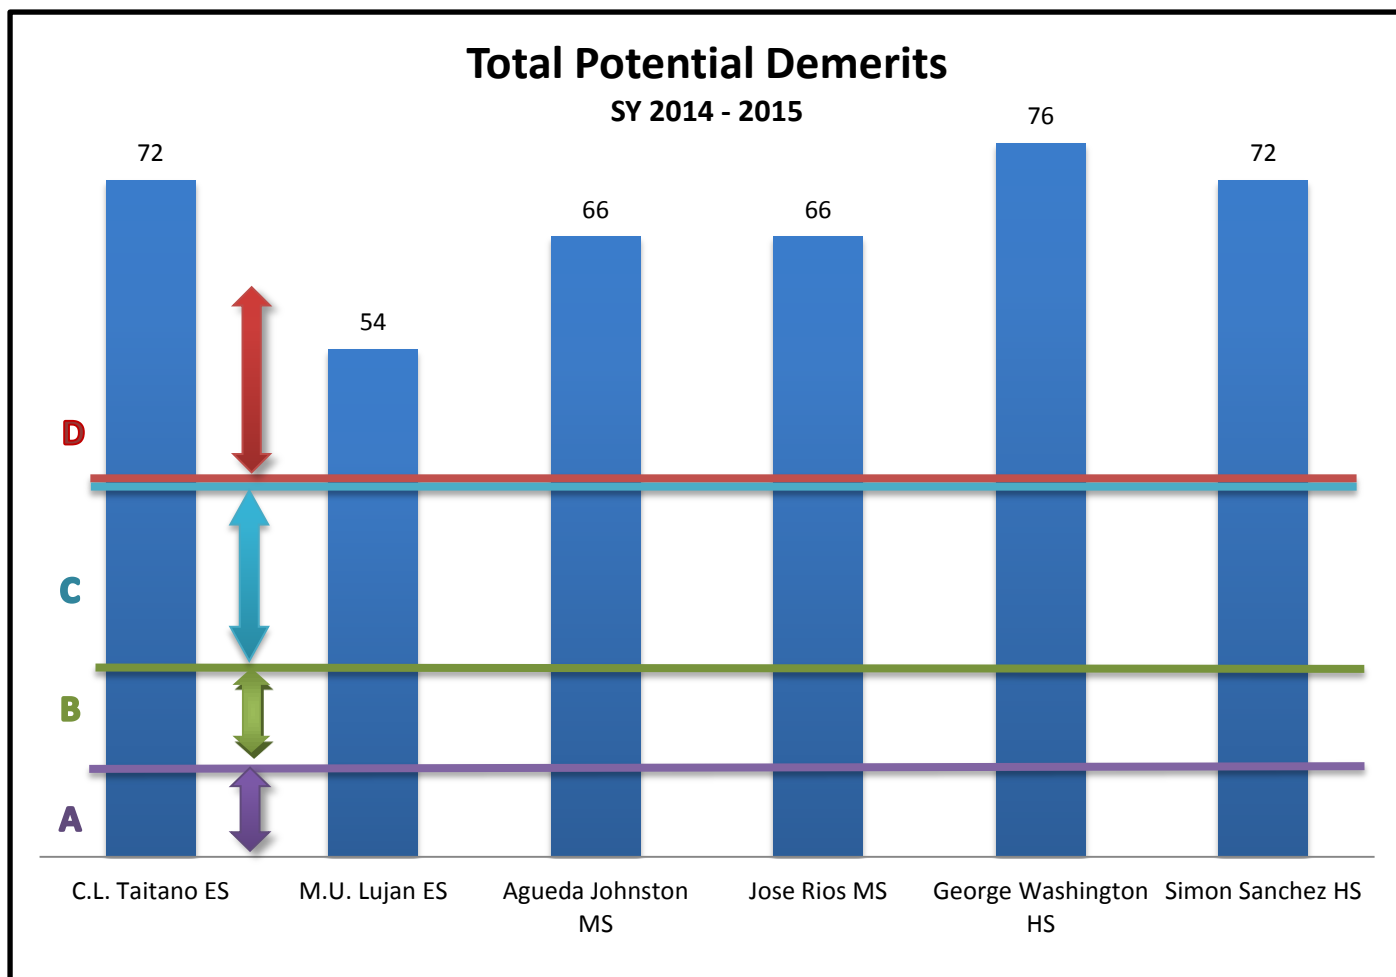
Figure 2. Total Potential Demerits by School, SY 2014 - 2015

Inspectors conducted assessments of each school, which means that demerits were not documented and schools were not given a grade; however, **Figure 2** indicates the total potential demerit points each school would have received if the assessment was an actual inspection. When a school has reached over 40 demerits, the grade is a D, which could result in a suspended sanitary permit that could potentially result in a closure of all or part of the school. The red line reflects the point at which the demerit points have reached the letter grade D. All six schools were significantly over the 40 demerit points at the time of the assessments.

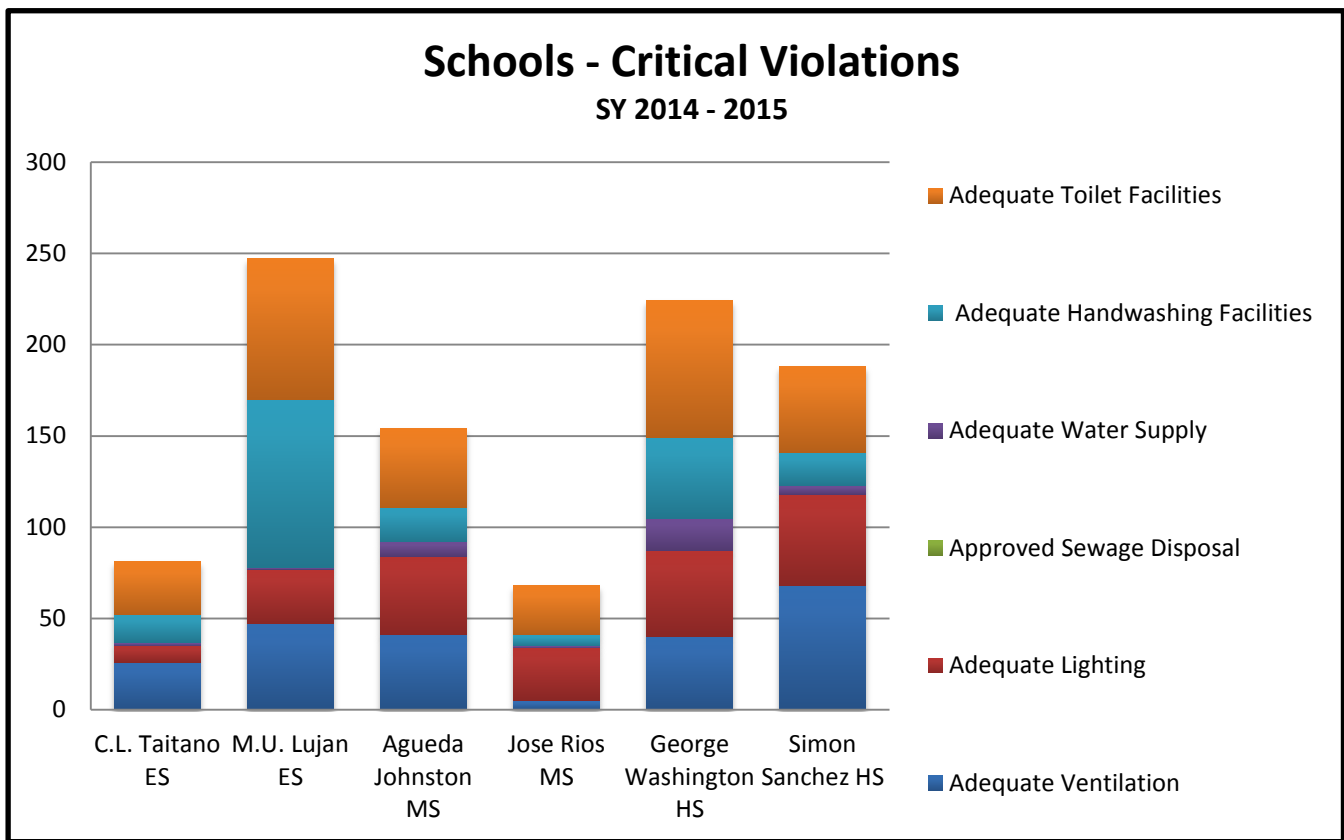
Figure 3. Critical Violations by Type per School, SY 2014 - 2015

Figure 3 reflects the total number of observed deficiencies at each school that are considered critical violations.

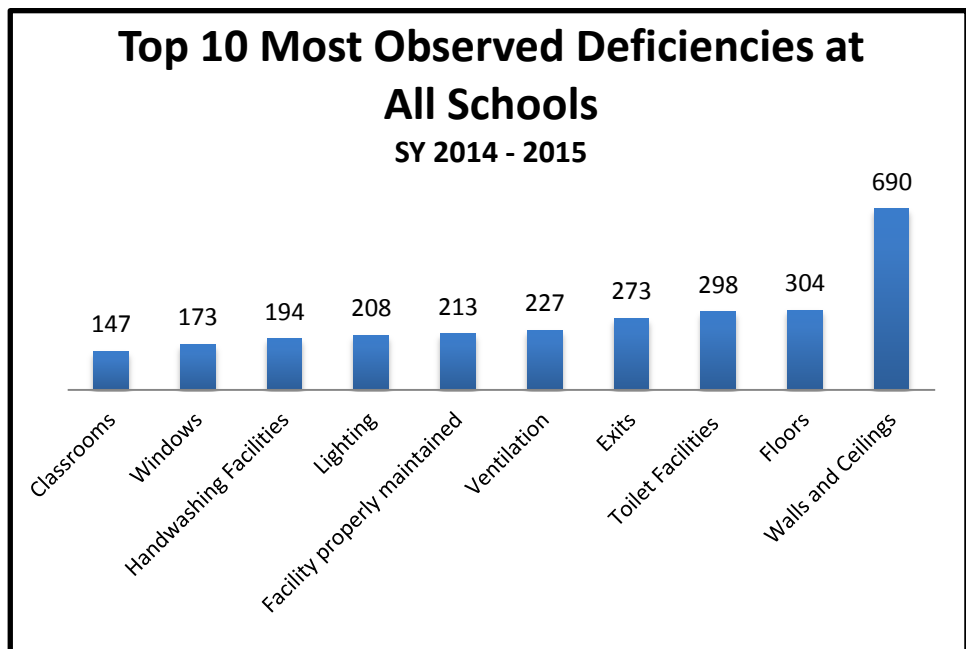
Figure 4. Top Ten Most Frequently Observed Deficiencies, SY 2014 - 2015

Although many deficiencies were observed at each school, **Figure 4** represents the most frequently observed deficiencies at all the schools. The most observed deficiency in all the schools is item number 13, in Section VI of the regulations, regarding walls and ceilings. There are many types of deficiencies that can be found within a school setting that can be considered a violation relating to walls and ceilings. The list below shows the observed deficiencies found

at the six schools during this assessment period. One deficiency we are observing more frequently is “water bubbles” in walls. The “water bubbles” occur when a leak, from rain for example, causes water or other liquids

to collect between the paint and the wall, forming pockets of liquid. This can occur on the exterior of a building when the paint does not adhere to the surface due to the use of inferior paint, lack of preparation, and other reasons. We are most concerned with this type of deficiency when it is observed inside a building because it most likely means there is a leak occurring in the room, which is a larger issue.

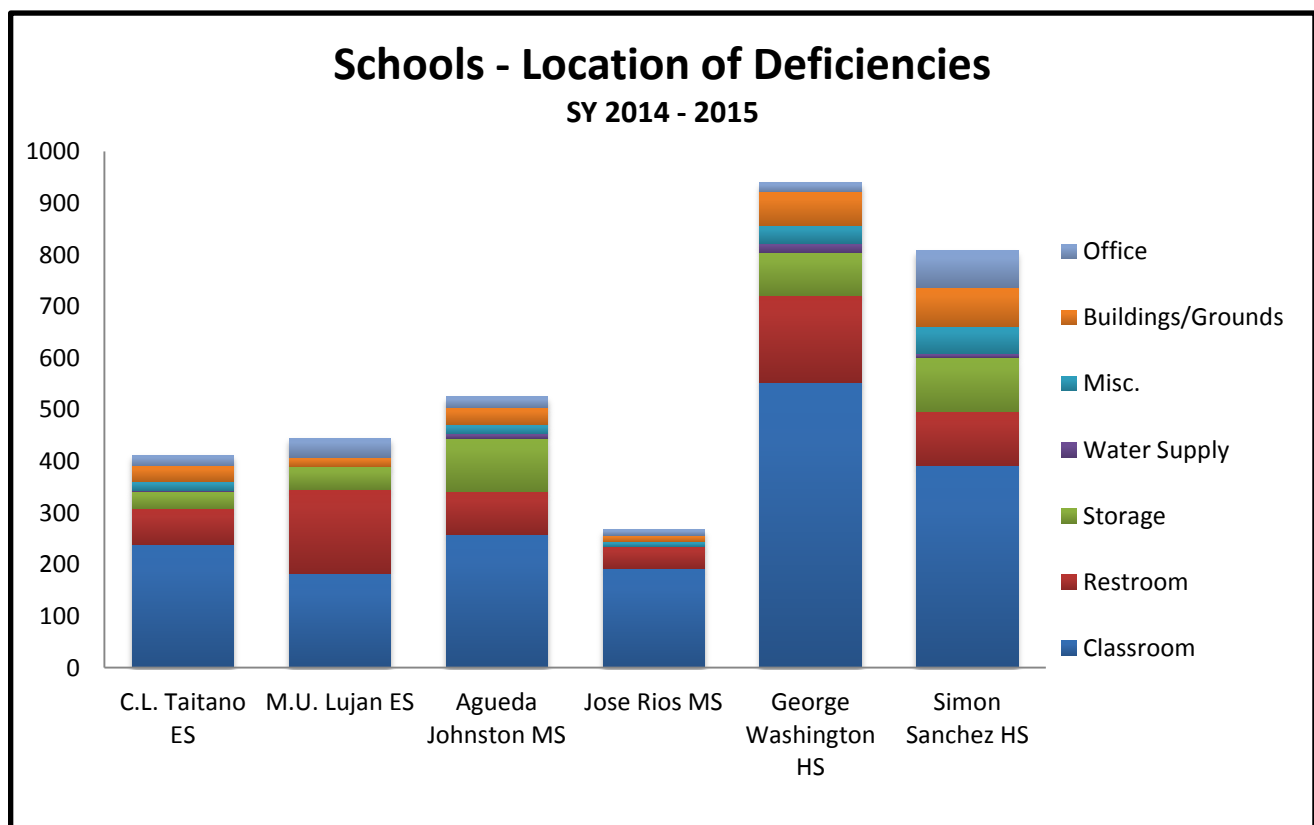
Figure 5. Location of Deficiencies per School, SY 2014 - 2015

Deficiencies can occur in or outside of the school buildings and are separated into seven location categories, including Office, Buildings/Grounds, Misc., Water Supply, Storage, Restroom, and Classrooms. The miscellaneous category includes dining areas, stages, libraries, gyms, locker rooms, multipurpose court, teacher’s lounges, and kitchens. DEH inspectors conducted walkthroughs of over 800 areas. **Figure 5** captures the location of the observed deficiencies at each school site. Most issues were observed in the classrooms (53.45%) and restrooms (18.59%).

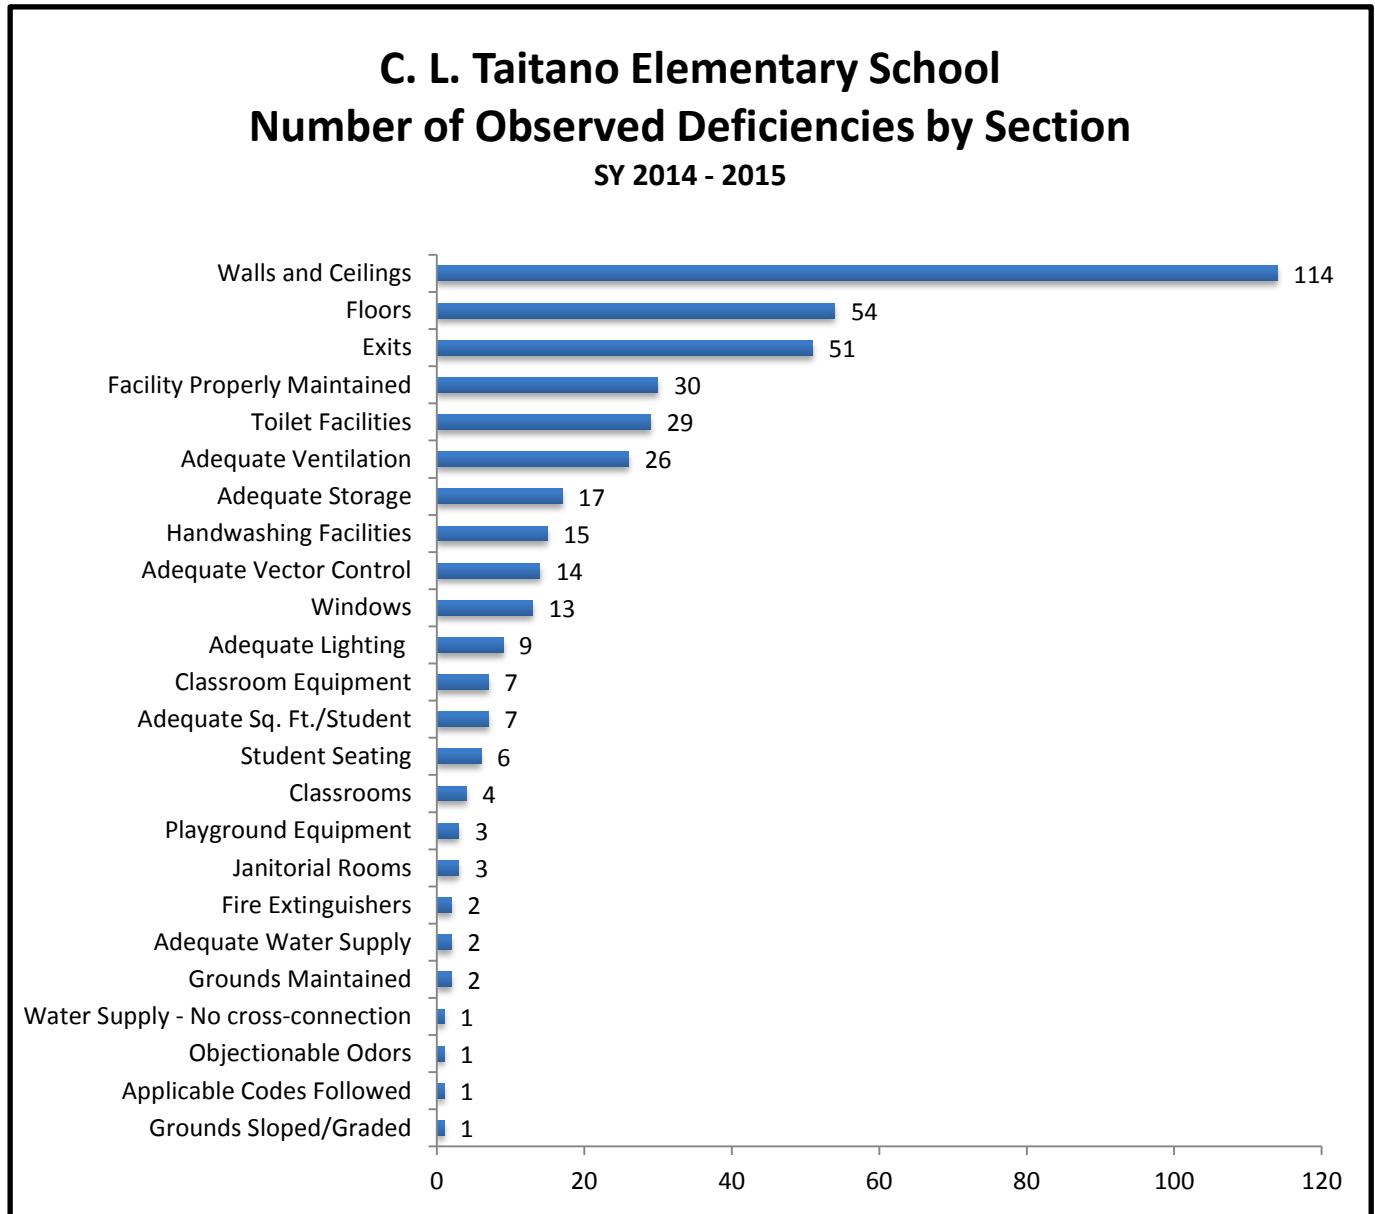
Figure 6. Number of Observed Deficiencies by Section: C.L. Taitano Elementary School, SY 2014 - 2015

C.L. Taitano Elementary School (**Photo 2**) is located in the village of Sinajana. The elementary school has a student population of 610. The school was assessed on December 12, 2014. During this assessment, DEH inspectors conducted a walkthrough of 79 areas. **Figure 6** depicts the observed deficiencies separated by the sections of the current regulations. Of the 39

possible violations, 24 violations were observed, totaling 412 observed deficiencies (**see Attachment A**). If this assessment were graded, C.L. Taitano would have received a score of 72, resulting in a letter grade of D.

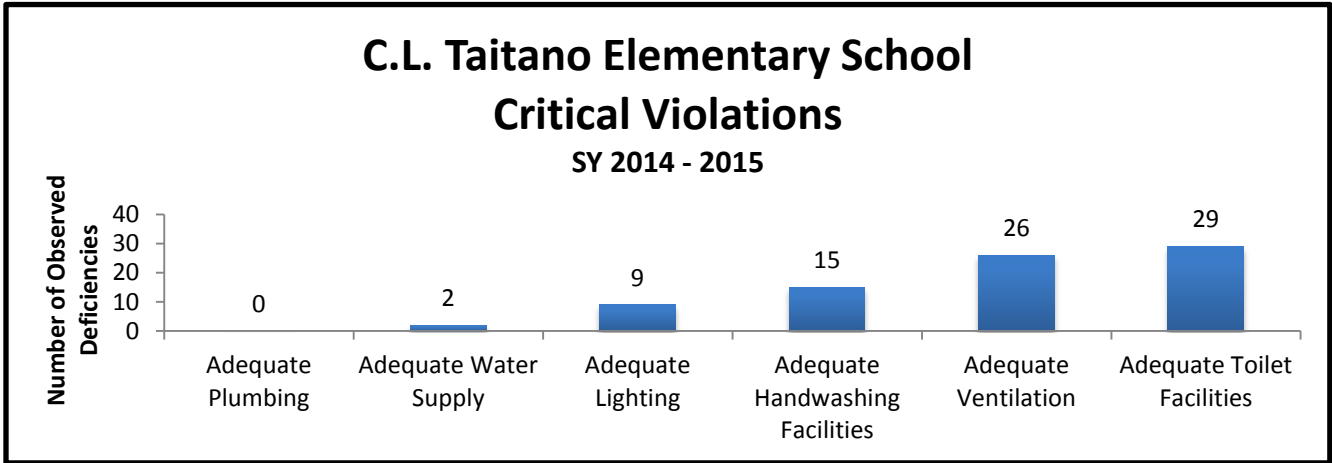
Figure 7. Number of Critical Violations: C.L. Taitano Elementary School, SY 2014 - 2015

Figure 7 is a breakdown of the observed deficiencies that are considered critical violations. Of the six possible critical violations, five were observed at the school, including adequate water supply, adequate lighting, adequate handwashing facilities, adequate ventilation, and adequate toilet facilities. The critical violations found were 19.6% of the total violations observed at the school.

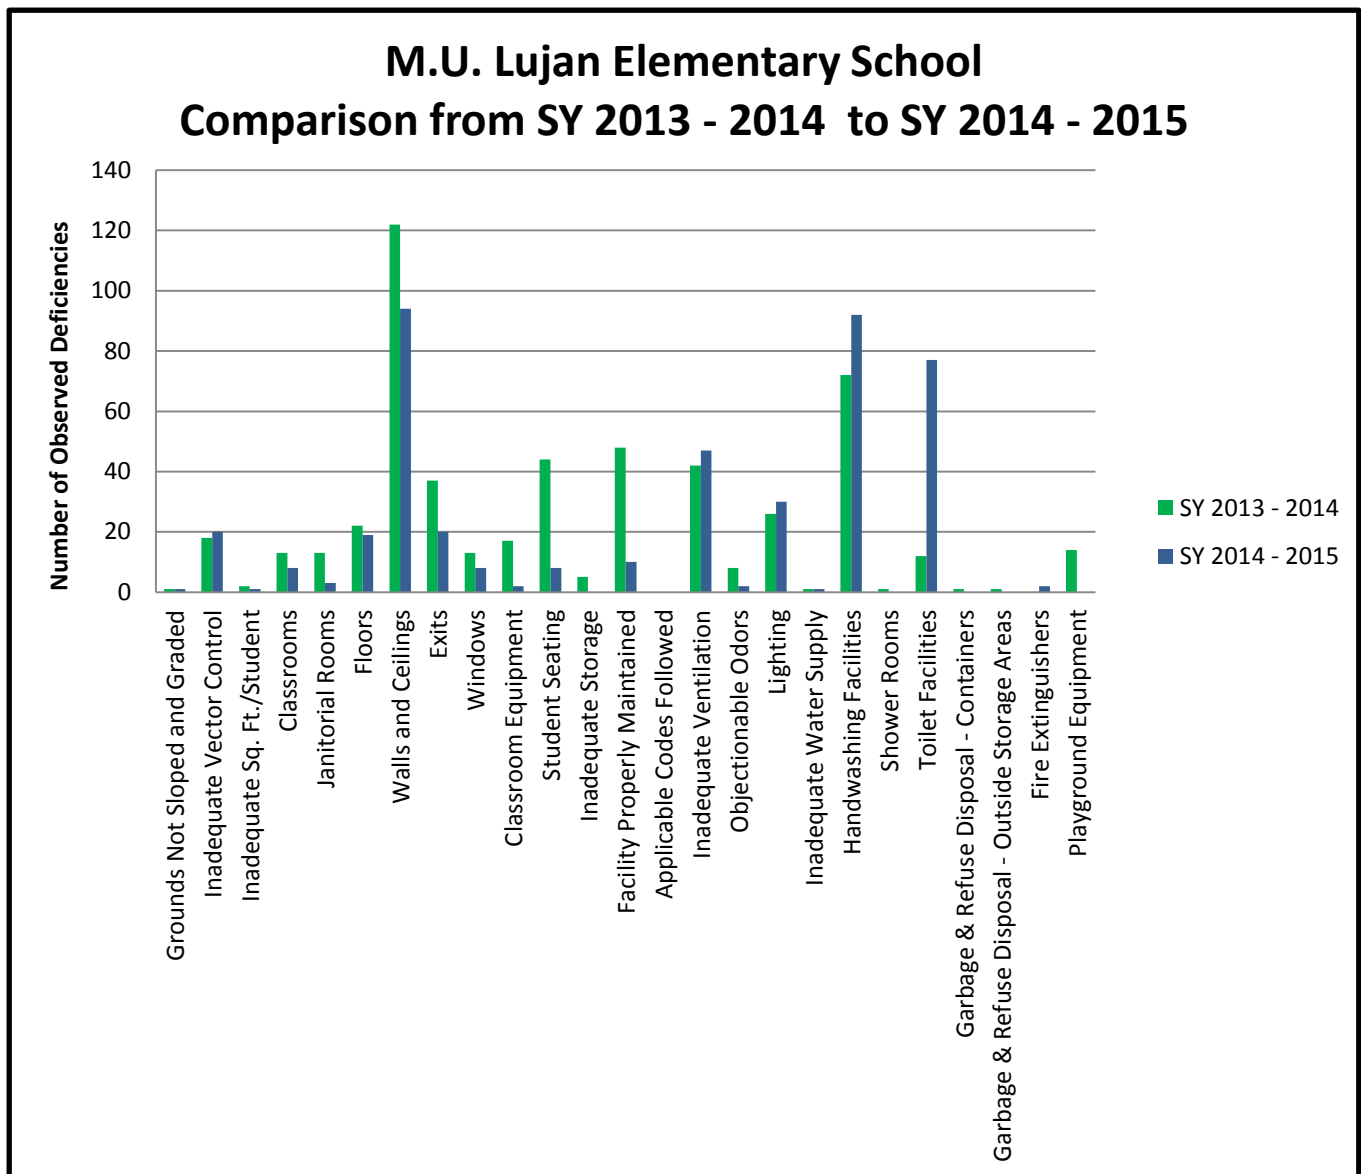
Figure 10. Comparison of Observed Deficiencies by Section: M.U. Lujan Elementary School, SY 2013 – 2014 and SY 2014 - 2015

Compared to an assessment conducted in January of 2014, M.U. Lujan had a 16.5% decrease in observed deficiencies. While this improvement should be commended, there are still great strides that need to be made in decreasing the number of violations at the school. **Figure 10** shows where the improvements have been made, as well as areas that have worsened over the year.

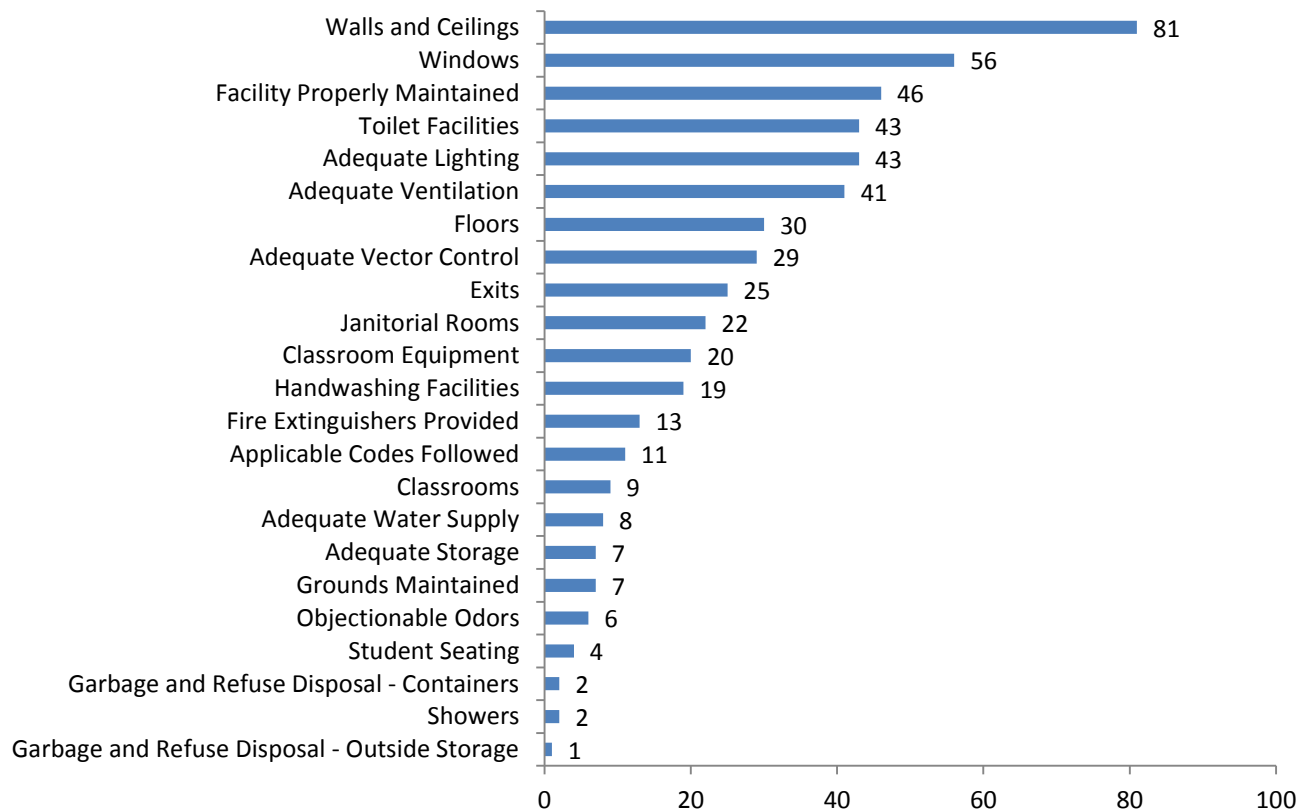
Figure 11. Number of Observed Deficiencies by Section: Agueda Johnston Middle School, SY 2014 - 2015

observed deficiencies (see Attachment C). If this assessment were graded, Agueda Johnston would have received a score of 66, resulting in a letter grade of D.

Agueda Johnston Middle School (**Photo 4**) is located in the village of Ordot-Chalan Pago. The middle school has a student population of 803. The second assessment of the school was conducted on December 11, 2014. During this assessment, DEH inspectors conducted a walkthrough of 138 areas. **Figure 11** depicts the observed deficiencies separated by the sections of the current regulations. Of the 39 possible violations, 23 violations were observed, totaling 525

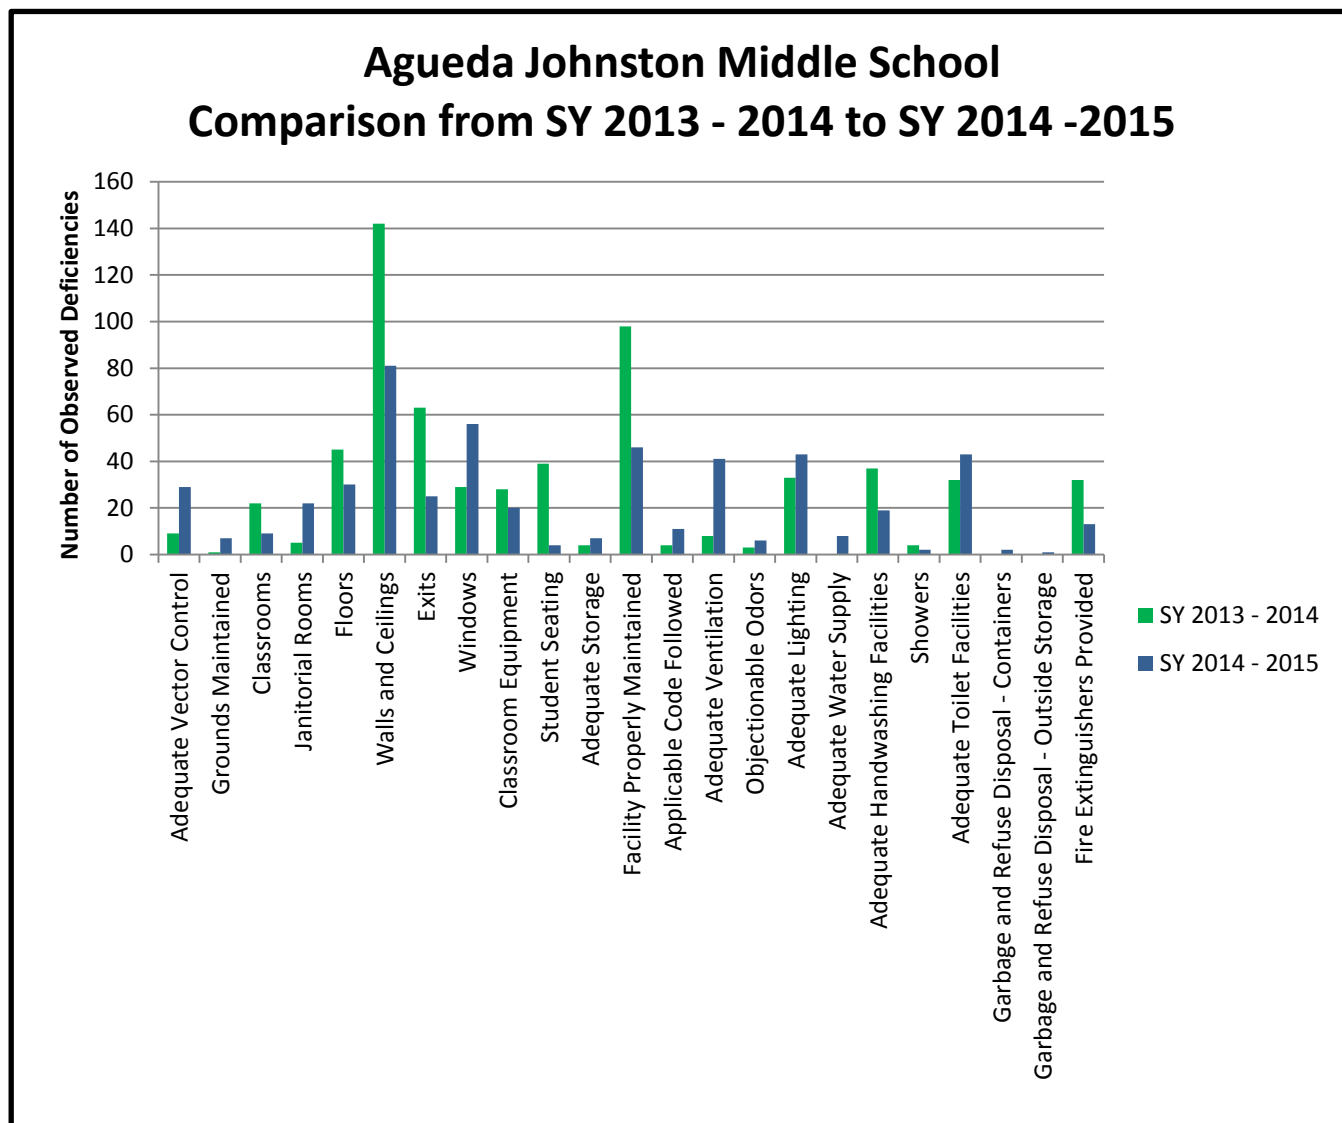
Figure 13. Comparison of Observed Deficiencies by Section: Agueda Johnston Middle School, SY 2013 – 2014 and SY 2014 - 2015

Compared to an assessment conducted in January of 2014, Agueda Johnston Middle School had a 17.7% decrease in observed deficiencies. While this improvement should be commended, there are still great strides that need to be made in decreasing the number of violations at the school. **Figure 13** shows where the improvements have been made, as well as areas that have worsened over the year.

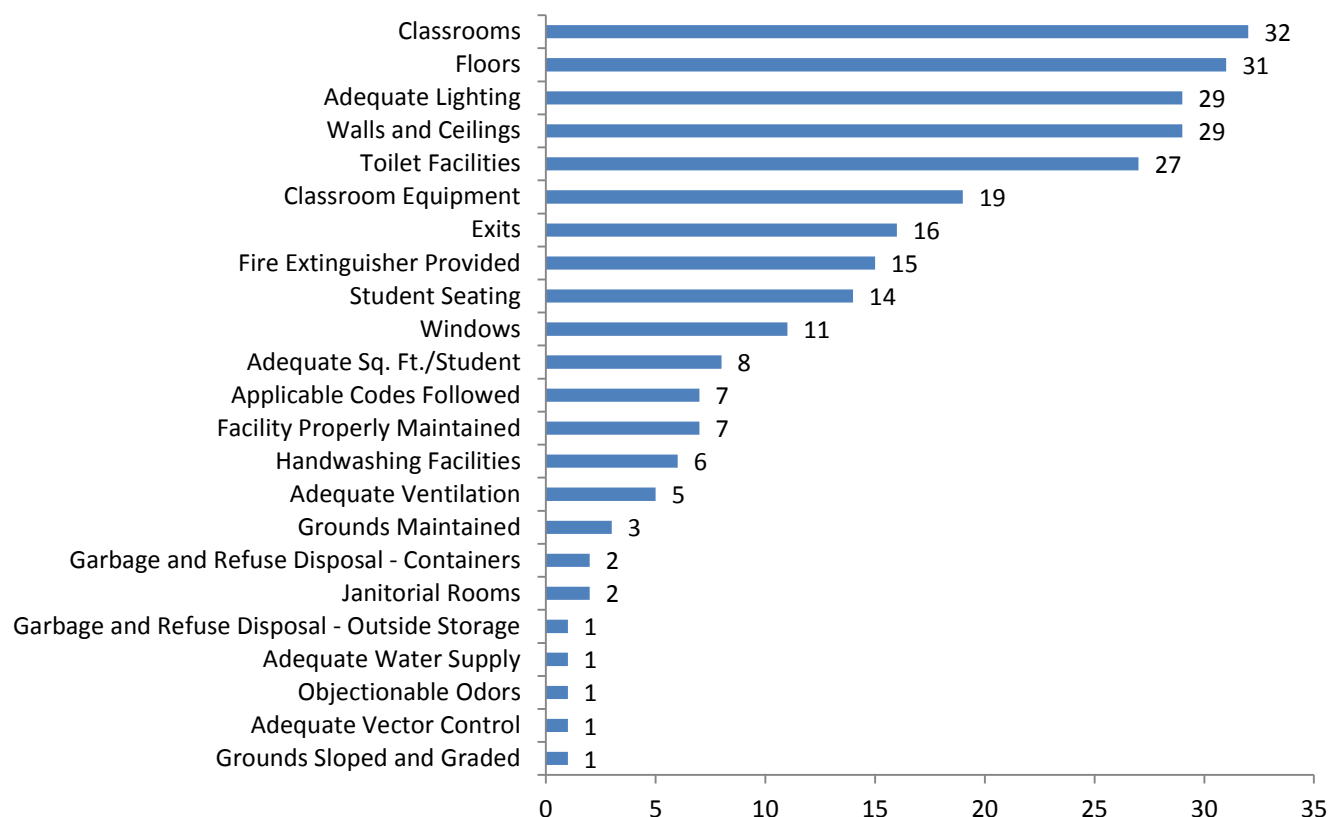
Figure 14. Number of Observed Deficiencies by Section: Jose Rios Middle School, SY 2014 - 2015

Jose Rios Middle School (**Photo 5**) is located in the village of Piti. The middle school has a student population of 874. The school was assessed on November 26, 2014. During this assessment, DEH inspectors conducted a walkthrough of 83 areas. **Figure 14** depicts the observed deficiencies separated by the sections of the current regulations. Of the 39 possible violations, 23 violations were observed, totaling 268 observed deficiencies (**see Attachment D**). If

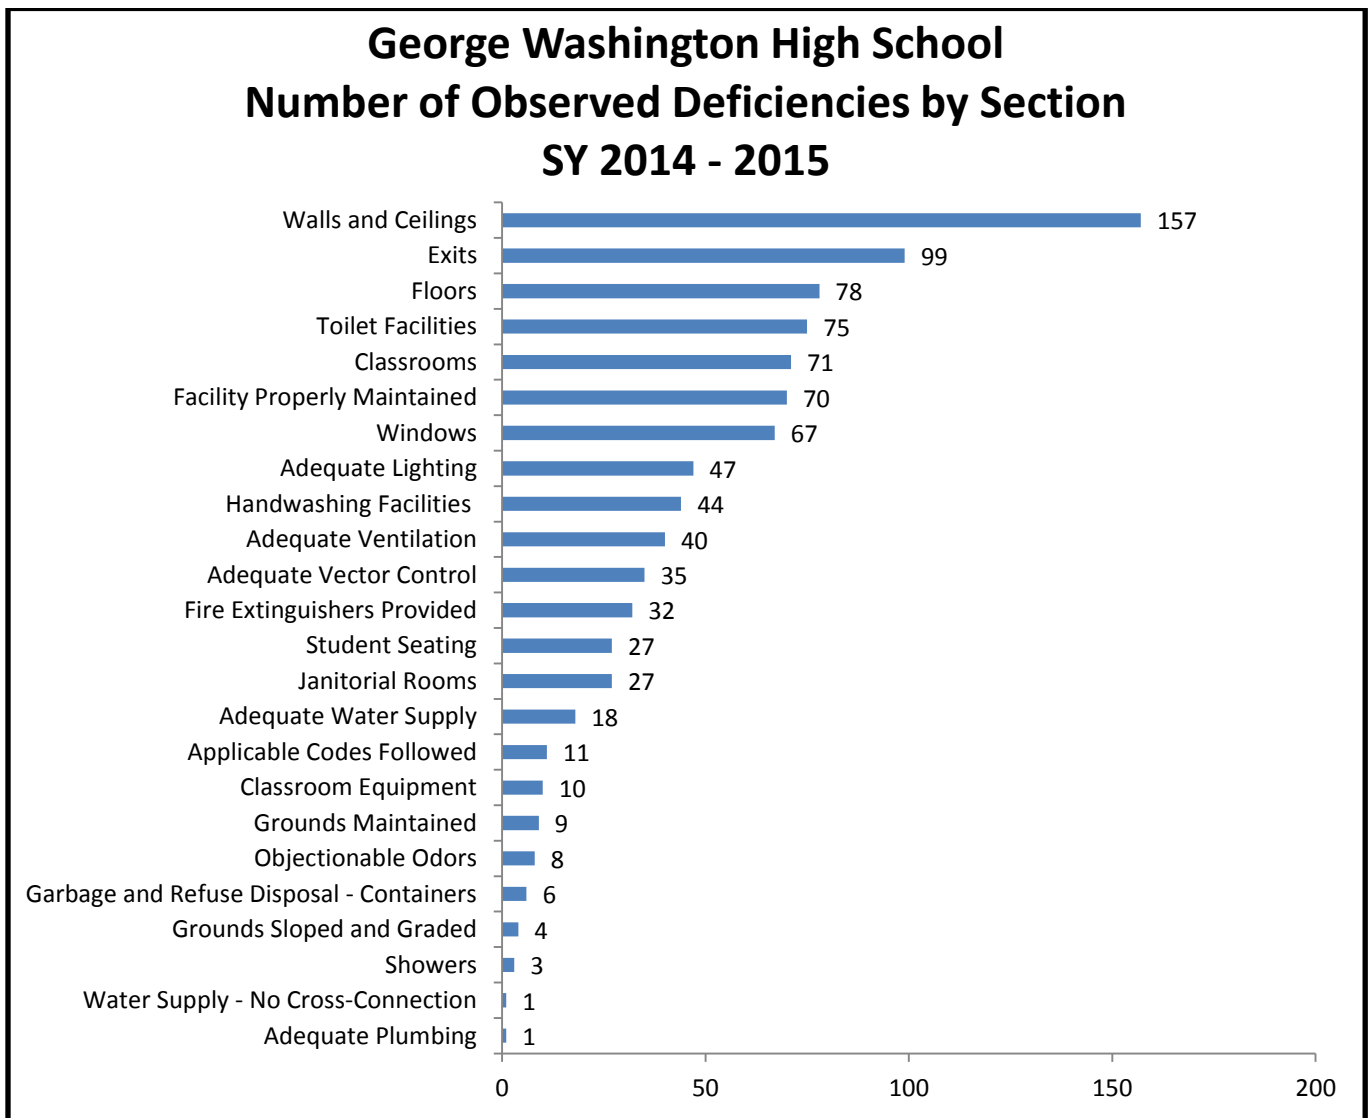
Figure 16. Number of Observed Deficiencies by Section: George Washington High School, SY 2014 - 2015

George Washington High School (**Photo 6**) is located in the village of Mangilao. The high school has a student population of 1,801. The second assessment of the school was conducted on December 1, 2014. During this assessment, DEH inspectors conducted a walkthrough of 216 areas. **Figure 16** depicts the observed deficiencies separated by the sections of the current regulations. Of the 39 possible violations, 24 violations were observed, totaling 940 observed deficiencies (**see Attachment E**). If this assessment were graded, George Washington High School would have received a score of 76, resulting in a letter grade of D.

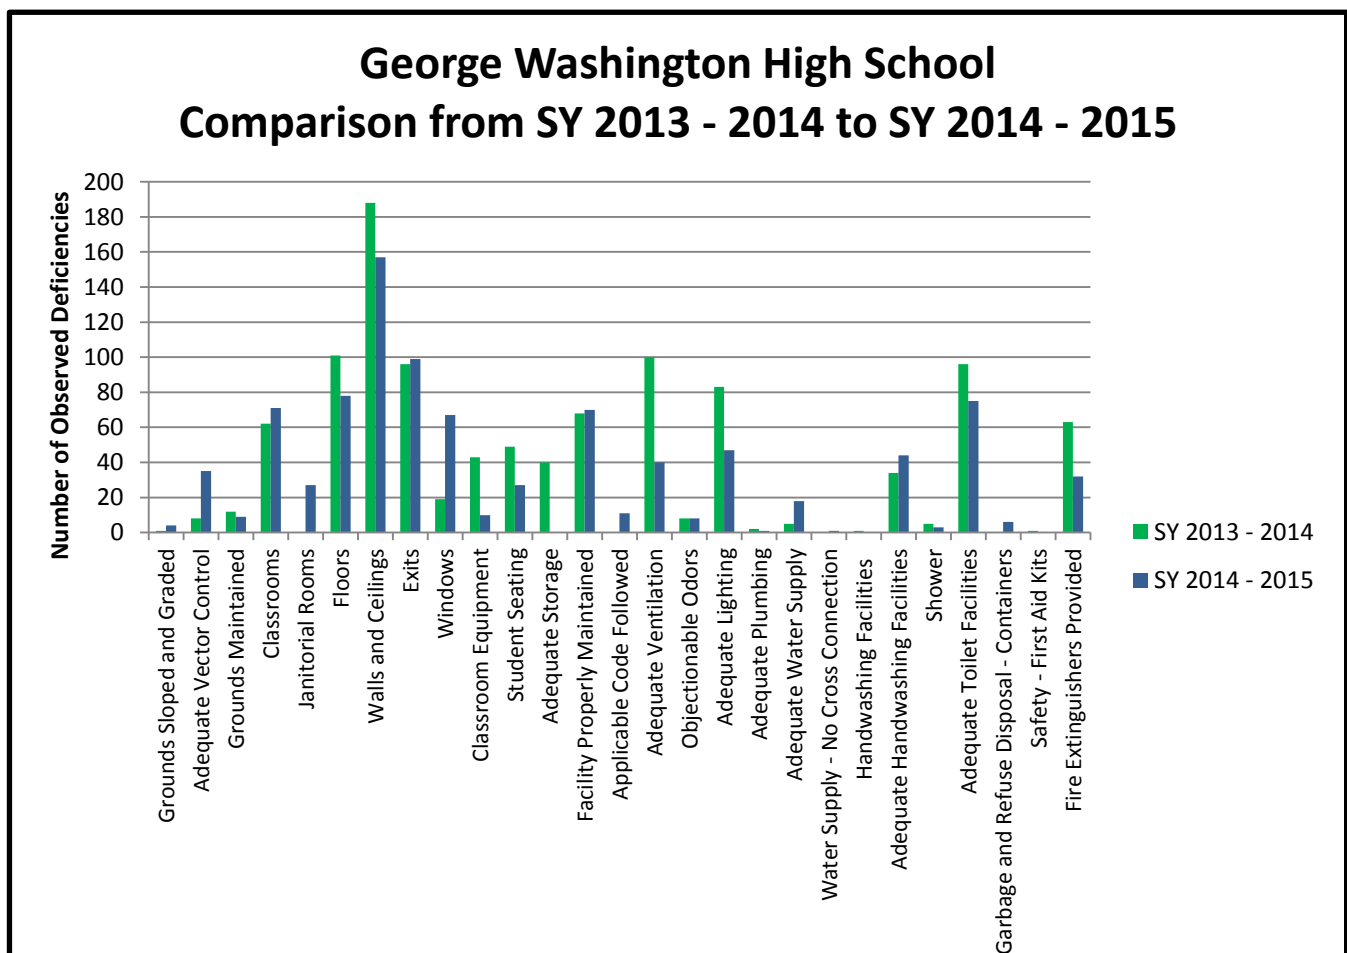
Figure 18. Comparison of Observed Deficiencies by Section: George Washington High School, SY 2013 – 2014 and SY 2014 - 2015

Compared to an assessment conducted in December of 2013, George Washington High School had a 13.36% decrease in observed deficiencies. While this improvement should be commended, there are still great strides that need to be made in decreasing the number of violations at the school. **Figure 18** shows where the improvements have been made, as well as areas that have worsened over the year.

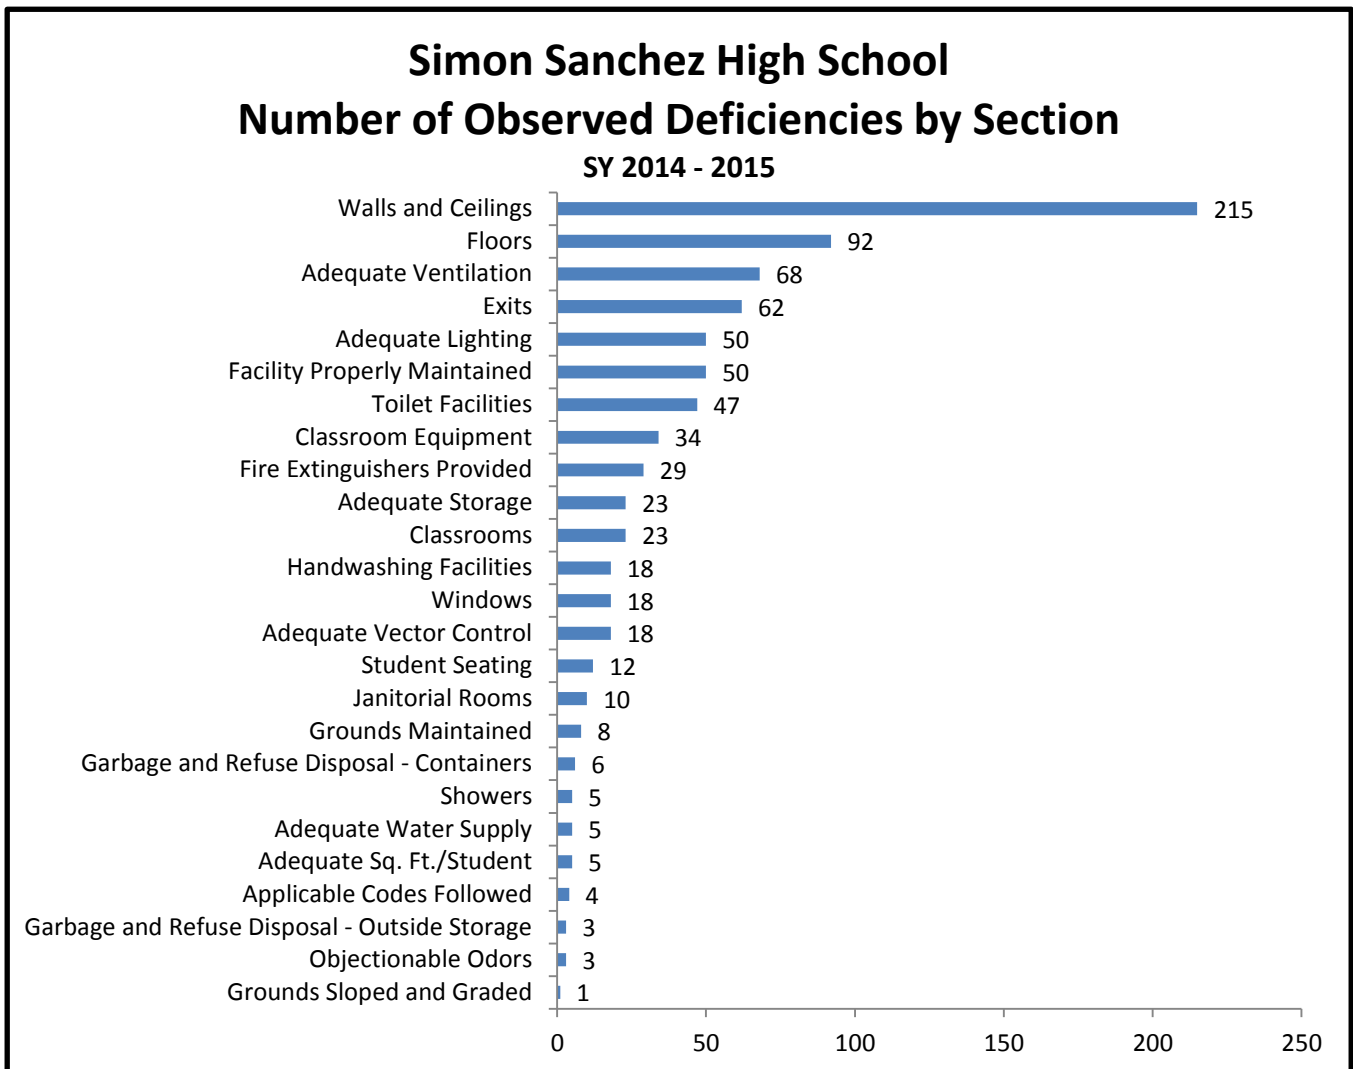
Figure 19. Number of Observed Deficiencies by Section: Simon Sanchez High School, SY 2014 - 2015

Simon Sanchez High School (**Photo 7**) is located in the village of Yigo. The high school has a student population of 1,835. The school was assessed on December 3, 2014. During this assessment, DEH inspectors conducted a walkthrough of 139 areas. **Figure 19** depicts the observed deficiencies separated by the sections of the current regulations. Of the 39 possible violations, 25 violations were observed, totaling 809 observed deficiencies (**see Attachment F**). If this assessment were graded, Simon Sanchez would have received a score of 72, resulting in a letter grade of D.

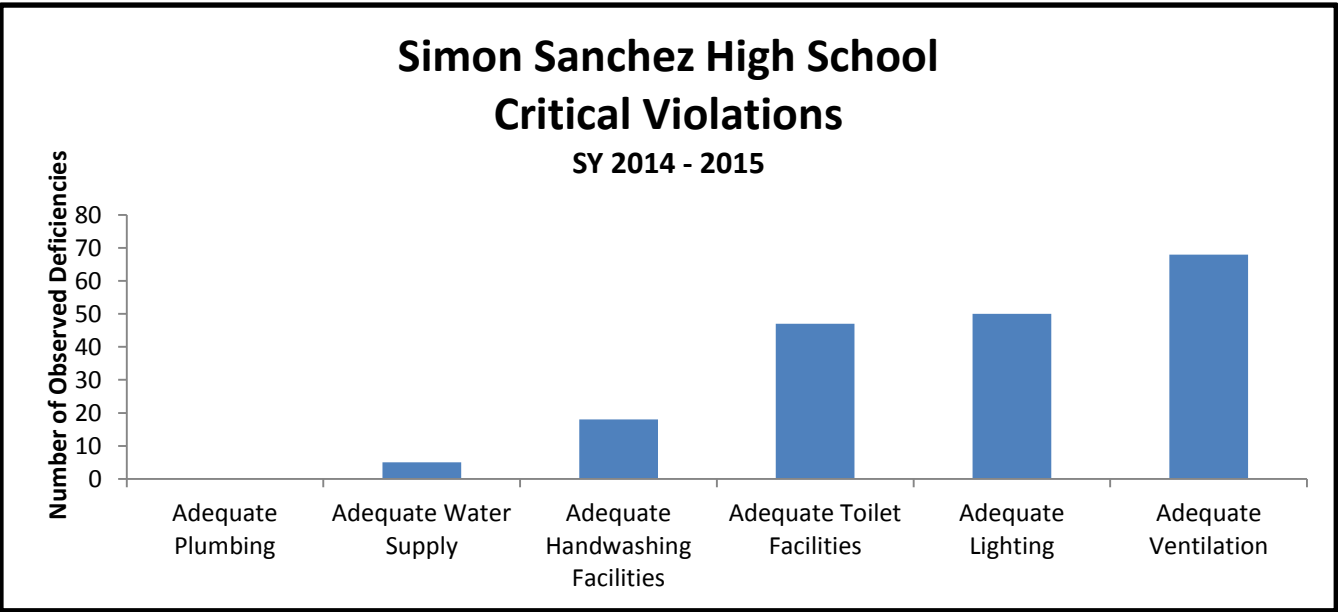
Figure 20. Number of Critical Violations: Simon Sanchez High School, SY 2014 - 2015

Figure 20 is a breakdown of the observed deficiencies that are considered critical violations. Of the six possible critical violations, five were observed at the school, including adequate water supply, adequate handwashing facilities, adequate ventilation, adequate lighting, and adequate toilet facilities. The critical violations found were 23% of the total violations observed at the school.
